RECENT HEAT STRAIGHTENING REPAIR JOBS

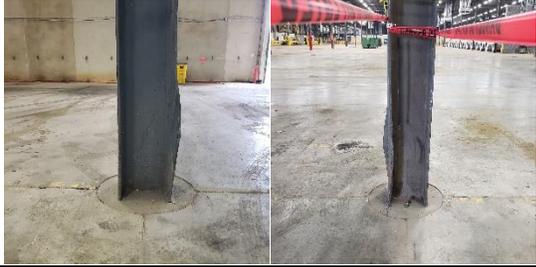
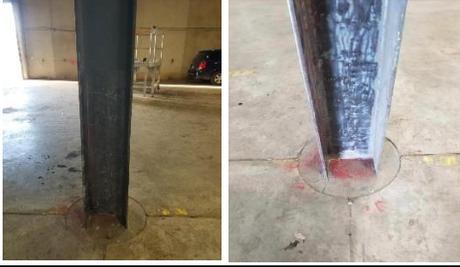
HSE Job Number	Owner	GC	Year Performed	Job Name	Description
F-5210170	High Associates	High Associates	2021	Building 225 Column Straightening	Straightening of building column that was hit by forklift
Before			After

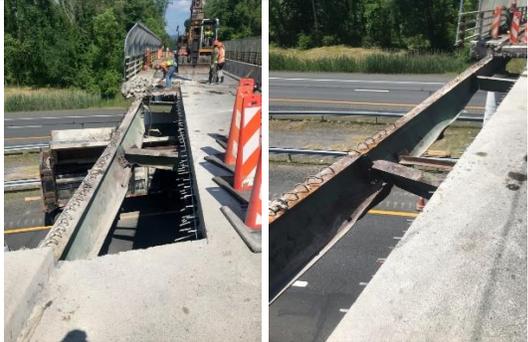
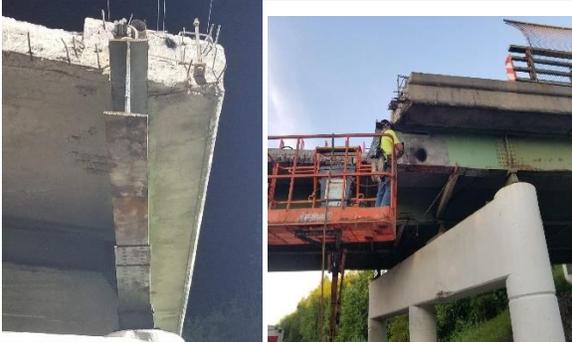
F-5200077	NYS DOT	Bette & Cring	2020	TANY 20-3B Brookside Rd Steel Repair	Removed portion of girder, then straightened ends due to extreme damage
Before			After

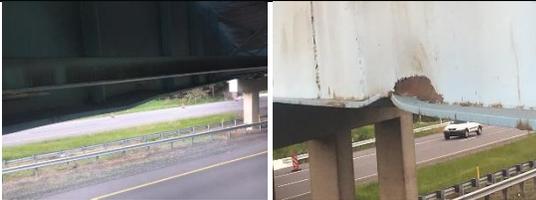
F-5190141	PADOT	HRI	2019	Centre Co Heat Straightening	Straightened girder then added cover plates to reinforce
Before			After
